MAINTENANCE OF THE N47 INTERNAL-COMBUSTION DIESEL ENGINE

TAMÁS FEKETE

Abstract: The N47 engine debuted in March 2007 in the facelifted BMW 1 Series E87 and E81 and was also available in the BMW 1 Series E82 and E88, which were introduced the same year. The N47 engine replaced the M47 engine that had been in production for 8 years. The M47 construction underwent several modifications, so the injection system was changed, the cylinder head now consists of two parts, and the engine block is made of aluminium. Two main versions of the N47 engine are known: N47D16 (1.6 L) and N47D20 (2.0 L). In the case of both versions, several models with different performances were born. After the distribution of BMW passenger cars equipped with the N47D20 engine, it received a lot of negative criticism due to malfunctions. In this article, I would like to present the maintenance of the engine, which can be used to avoid the failure of passenger cars equipped with the N47D20 diesel engine with huge material damage.

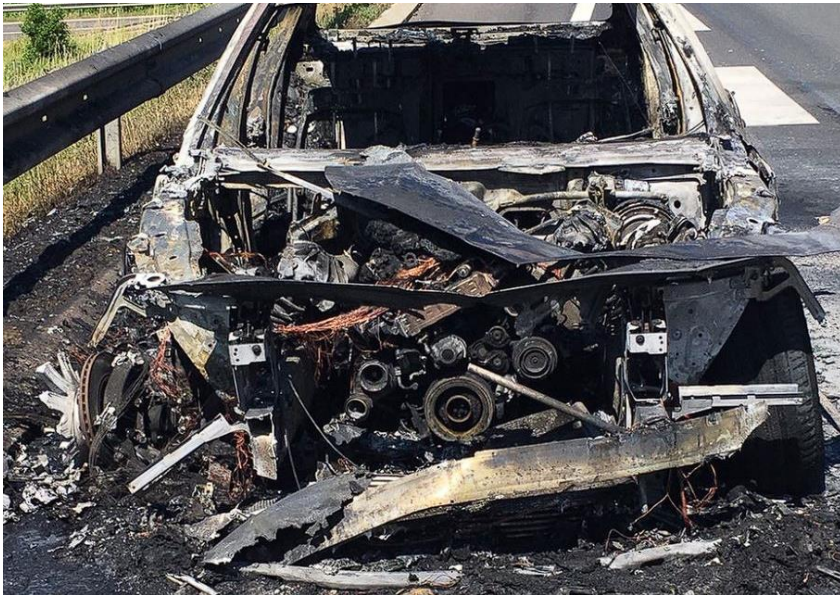
If the vacuum hose supplying the EGR (Exhaust Gas Recirculation) cooler bypass valve gets a hole rubbed in it, or breaks down from old age and oil spray, the EGR cooler will not get bypassed during the engine warmup period. This causes excessive build-up in the cooler matrix, and when the engine warms up these solid chunks of build-up can detach from the EGR cooler and get sucked into the plastic intake tube, melting holes in the intake tube, causing a massive boost leak and in very rare cases an engine fire (*Figure 2*). BMW has issued a recall to over 1.6 million vehicles in 2018 for the EGR issues (Braithwaite-Smith G.: Massive BMW diesel engine recall is expanded, *Motoring Research*, 2019).

Figure 2. Vehicle with N47 engine after catching fire

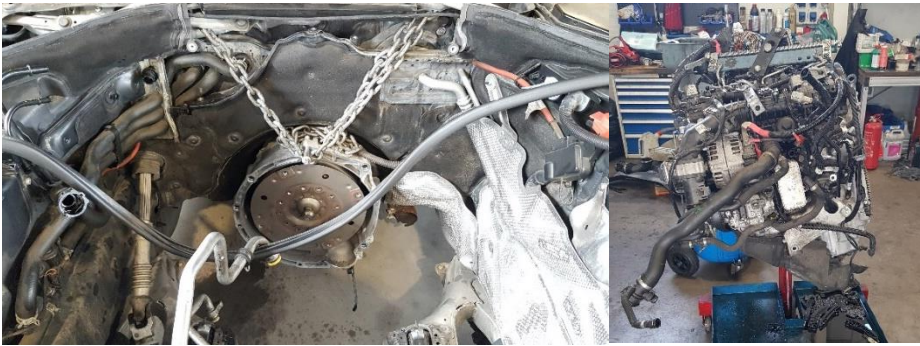
Figure 3. The engine compartment without the engine and the removal of N47 engine

The first and most important thing is to replace the timing chain and its associated components (sprockets, tensioners, etc.). Since the timing chain is located at the rear of the N47 engine, it is recommended to remove the engine block for professional inspection and repair work (*Figure 3*).

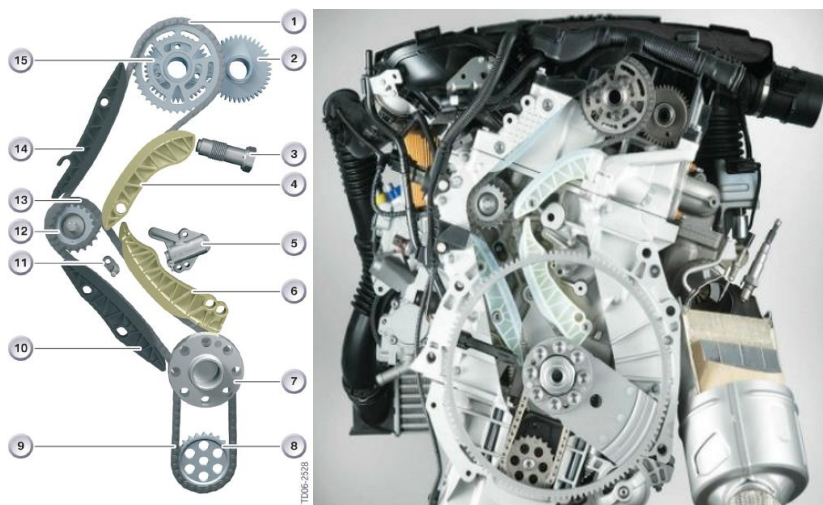
Timing chain elongation can also be determined from the condition of the tension cartridges (*Figure 4*).

Figure 4. The timing chain system
(*Tumblr, N47 timing chain, source of a picture*)

Since the engine block must be disassembled for the inspection, replacement is recommended even if the timing chain is still in good condition. If the timing chain is broken in the block, further tests are suggested to determine the exact damage.

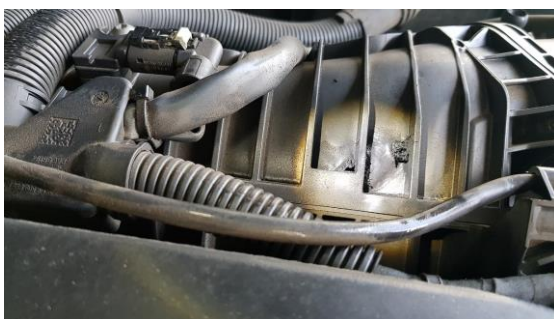
Figure 6. Melting of the cover on the engine as a result of the puncture of the intake pipe

If the complex error of the EGR system occurs on the highway in the summer, the vehicle will most likely catch fire.

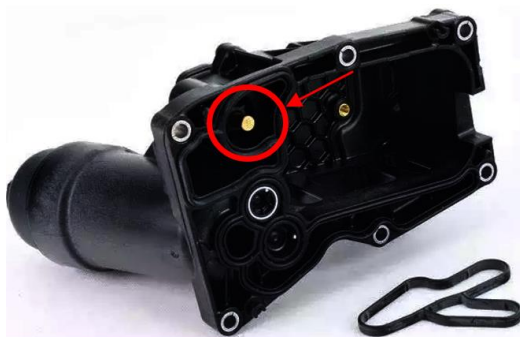
It is worth replacing the oil cooler seal together with the timing chain. A characteristic symptom of seal wear is the formation of oil sludge under the oil cooler. The shaft located at the bottom of the oil filter housing (*Figure 8*) and oil cooler must be checked, as it is possible that the socket is cracked, which may later lead to premature failure of the engine bearings.

Figure 8. Oil filter housing shaft. The socket may crack

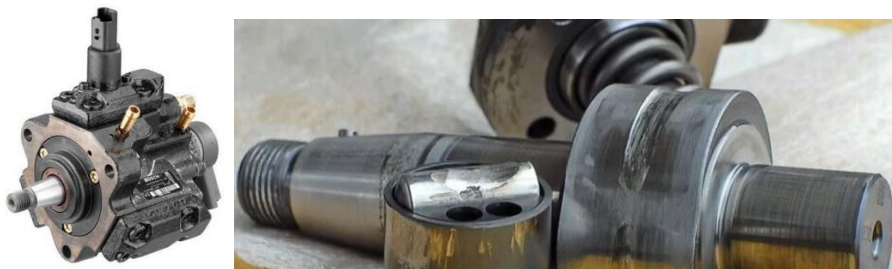
The easiest way to check is to remove the sensor from the pump and check the condition of the shaft (*Figure 9*). If we find that, in contrast to the factory shine, it has started to dull (piston, shaft), it is worth refurbishing or replacing it. If the piston rotates relative to the shaft, the fine metal dust coming off the shaft as a result of friction can enter the fuel supply system and cause enormous damage.

Figure 9. *The high-pressure fuel pump, and wear resulting from the sticking of the piston, which results in the entry of metal dust into the system (BMW E91 N47 high pressure pump failure and repair, YouTube, source of picture)*
